Erosion control in mining applications

# Using geosynthetics to stabilize soils in a harsh environment

By Dhani Narejo, Bruno Hay, and Bryan Wedin

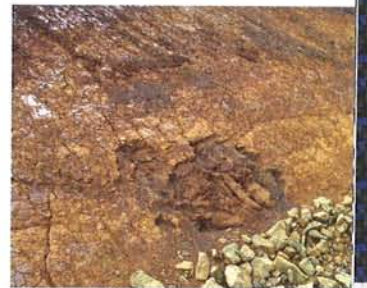
**FIGURE 1** A typical progression of erosion at one of the slopes

For such a large site, the challenge of protecting the structures from erosion can be enormous. Inaction is not an option due to the sensitive nature of the structures, environmental concerns, and a keen desire by the owners to protect the environment. A typical example of the erosion at the site is the slope in **Figure 1**. Such slopes require continuous maintenance if the erosion problem is not addressed. In some cases, erosion can cause interruption in the mobility of materials and personnel at the site.

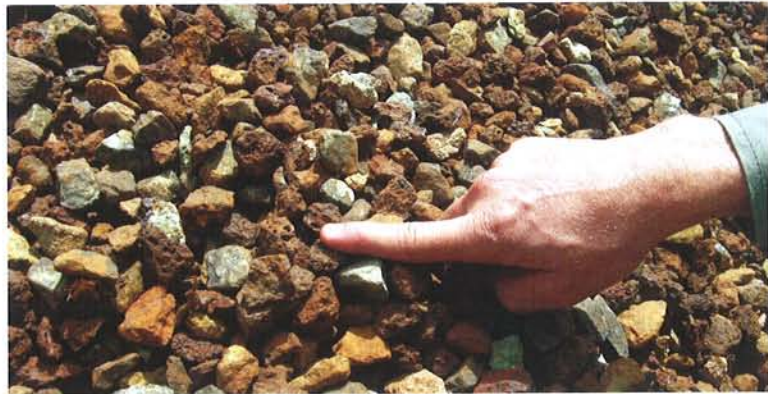
FIGURE 3 Gravel used as the infill in the geocell

The owner suggested the potential of geocell applications to develop a conceptual solution to the erosion problems. The solution consisted of covering the slopes with geocells, a 3-D HDPE product designed to contain and stabilize infill material. The recommended infill material consisted of a byproduct waste aggregate from the mining operation. A nonwoven, needle-punched (NW-NP) geotextile separation layer was also recommended. **Figures 3 and 4** present the proposed gravel infill and the geocell, respectively.

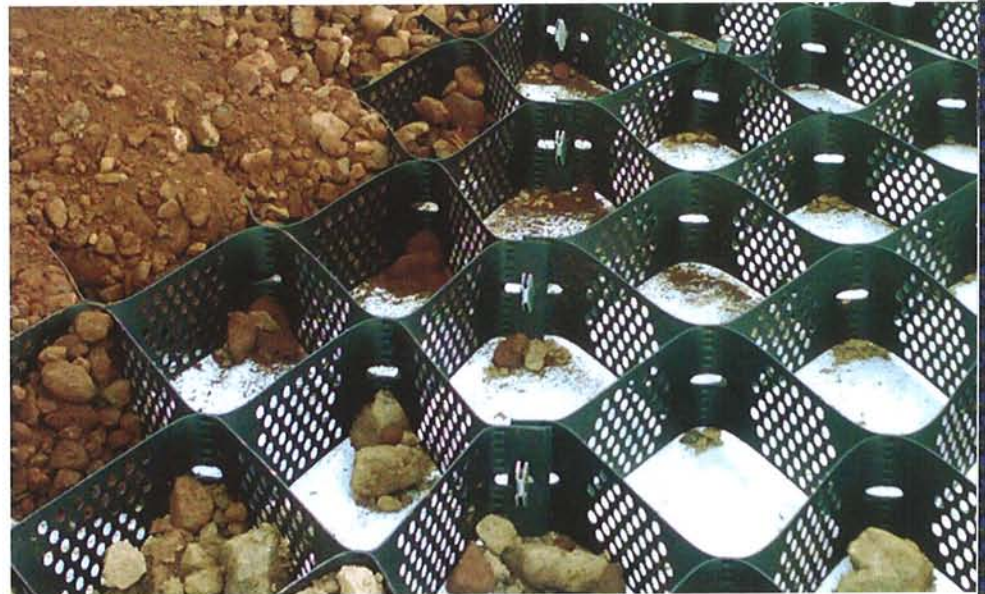
FIGURE 4 Expanded and connected geocell sections partially infilled
